Board of Education Capital Plan FY17-FY21

PROJECT TITLE: New Roof Tolland Intermediate School

TOLLAND INTERMEDIATE SCHOOL
96 Old Post Road
TOLLAND, CT

**Tolland Intermediate School
96 Old Post Road
Tolland, CT**

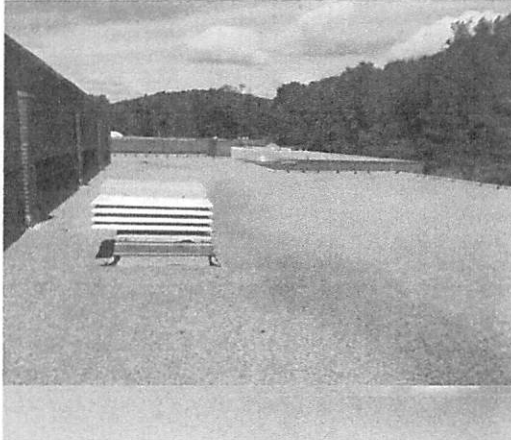
Photo #1: Overview of the West side of the School, Section E

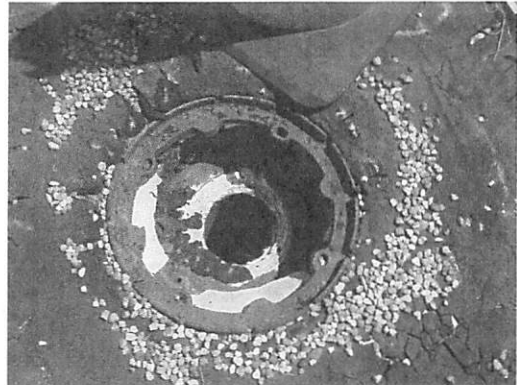
Photo #2: Drain is not clamped down on the West side of Section E

- 1) Repair perimeter flashings as required
- 2) Repair unclamped drain
- 3) Repair all eroded felts as required
- 4) Repair drain and skylight
- 5) Repair opening in flashings and EPDM Portables

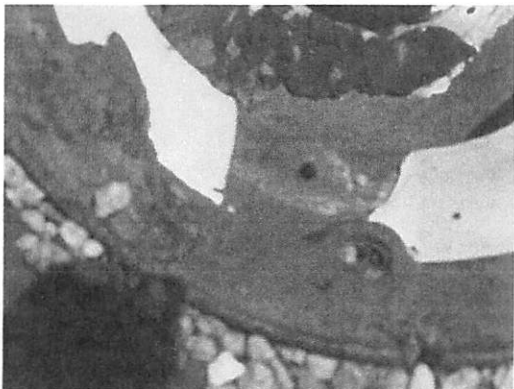
Photo #3: Bolts are not lined up, somehow the drain shifted or was never clamped down to begin with.

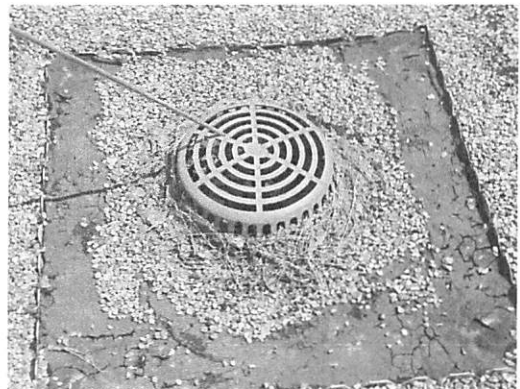
Photo #4: Debris along the drain, again on Section E and throughout

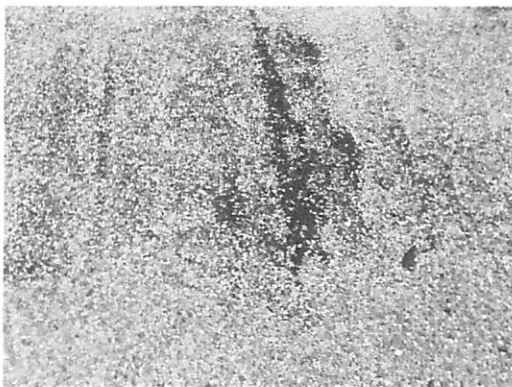
Photo #5: Eroded felts throughout all sections

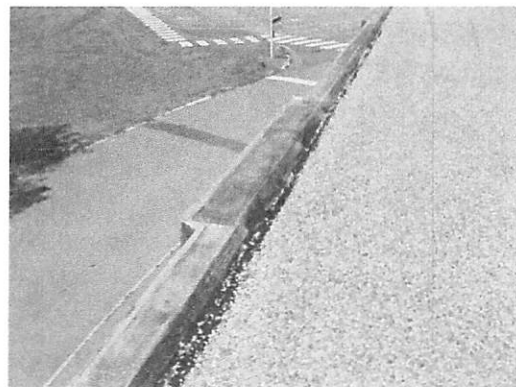
Photo #6: Faded aluminum coating along the East side perimeter on Section B

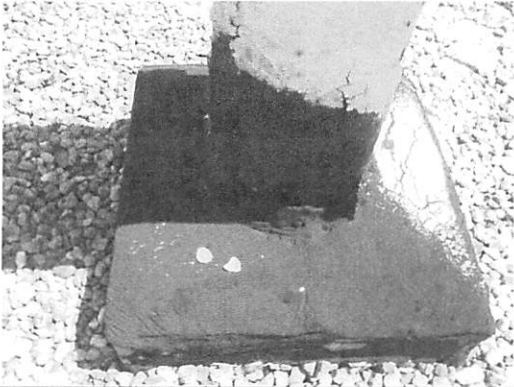
Photo #7:	Pitch box with openings on Section B
-----------	--------------------------------------

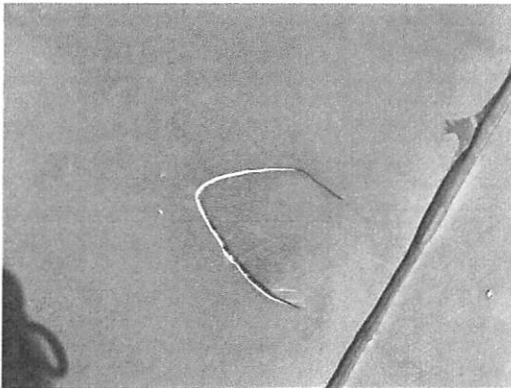
Photo #9:	Another example of the numerous openings in the portables, again this is on Section A
-----------	---
